SafeChurch® Preventing Copper Thefts

Preventing Copper Theft

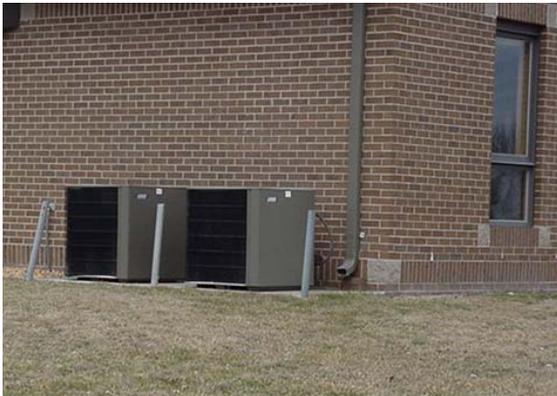
Example: This photograph illustrates AC units located at the back of the building creating an easy target for theft.

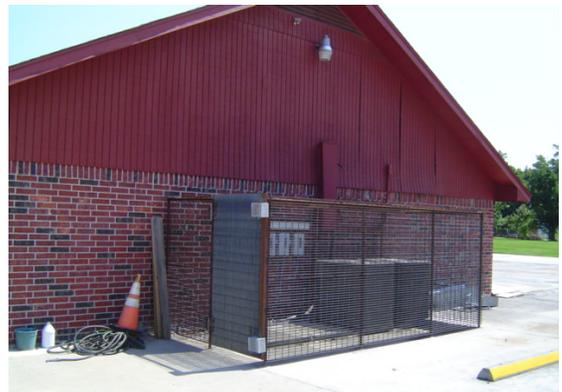
Example: This photograph illustrates AC units protected by a steel cage and security lighting.

- Consider the use of steel cages to enclose your AC units. The heavier the gauge of steel the longer it will take to cut. For example, 10-12 gauge steel can take one to two hours to cut. Do not use standard chain link fencing as it can be cut quickly.
