Knob and tube wiring gets its name from the knobs, or insulators, used to keep the wires isolated from objects and the ceramic tubes used to line holes (for example, through wooden floor joists). This type of wiring was installed up until the year 1950 and, although not common, can still be found in use today.

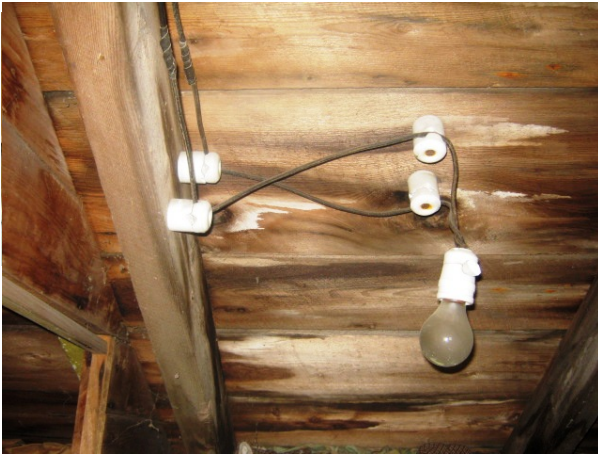
This image shows knob and tube wiring supplying power to a light fixture.

Knob and tube wiring is different from modern day wiring in that it consists of only two wires; a hot and neutral, there is not a ground wire. Both wires run separately to fixtures as opposed to all three wires contained within one plastic sheath like in today's applications.
